IPOS – Turf and Soil Assessment

Turf and Soil Assessment Summary

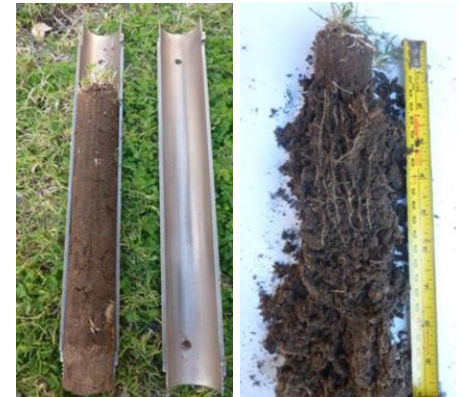
Soil profile / root density

Data collected in the field is entered into the IPOS Online system where it is analysed according to set parameters and industry benchmarks. Results are presented both as data tables and graphically on aerial mapping using GPS references. Comments and recommendations are made based on results. Sound turf maintenance programs can then be developed specifically for each sports ground. Results can be monitored over time to ensure the programs are effective. All data and reports can be accessed anytime, from anywhere.

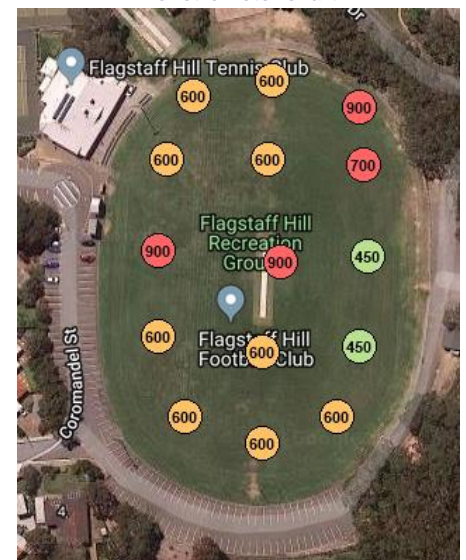
Penetrometer chart

Hydraulic Penetrometer Test Notes

Soil Strength
Measured using a hydraulic penetrometer the soil strength was generally acceptable to 150mm increasing down the profile. De-compaction work with an earthquake slicer to 250mm will mix
